PROPERTY INSPECTION REPORT

Inspector: Brian Abbott

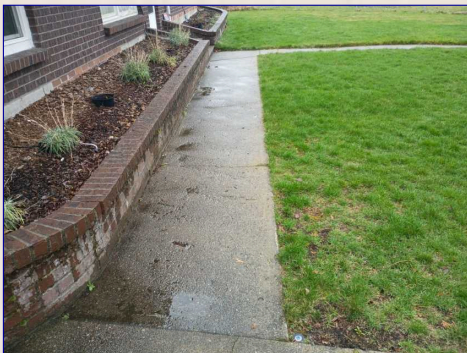
The Service Walk View

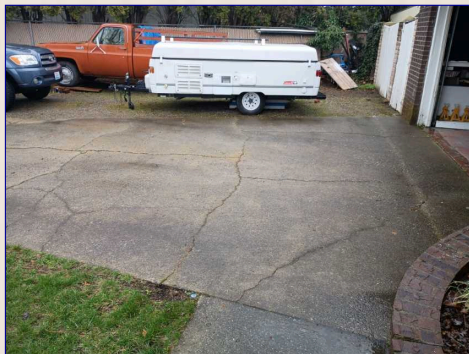
- The driveway has areas of spalling. Spalling is a common surface imperfection. Recommend a professional contractor repair to help prevent additional damage.
- The driveway is cracked. Recommend sealing the cracks to help prevent additional damage. Consult a professional contractor as needed.
- The driveway material was dirt/gravel and will need routine grading maintenance. Recommend grading as required.
- **The driveway had cracked areas, which could be a tripping hazard. Recommend using additional caution in these areas. Repair or replace as needed.**

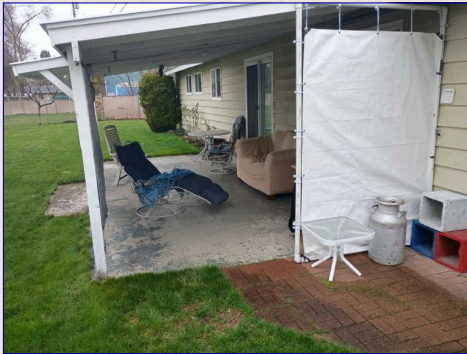
- The patio has expected cracks. Recommend a professional contractor seal the cracks to help protect the cement from damage.
- The patio has areas of spalling. Monitor for damage and consult with a professional contractor to replace the slab as needed.
- The patio had some cracking and settlement but was in usable condition. Repair as needed.

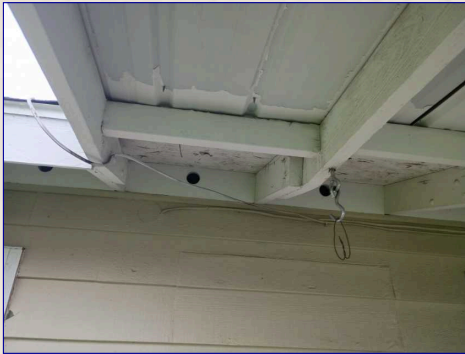
The Deck/Porch/Patio Cover View

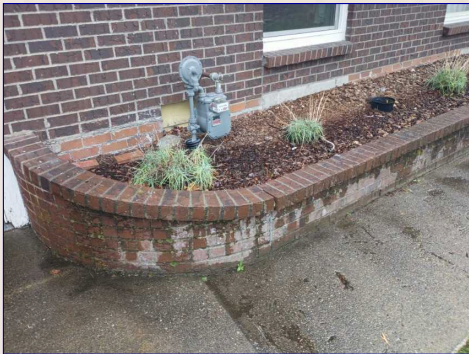
Front Flowerbed View

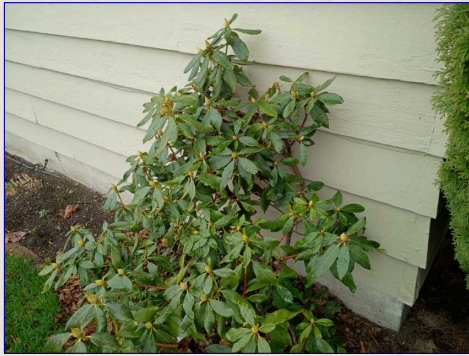
They were flower beds next to the house/foundation. Watering plants next to the foundation can put excessive amounts of water on the foundation wall. Recommend moving/removal of the flowerbeds.

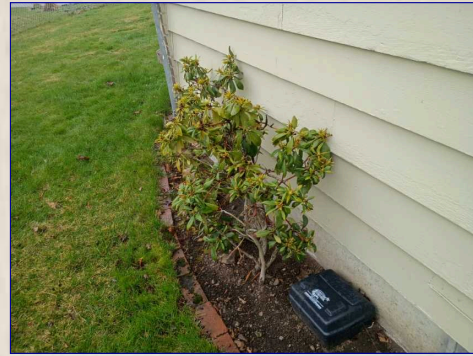
There is vegetation in contact with the house. Recommend trimming trees/vegetation, so it is doesn't come into contact with the home.

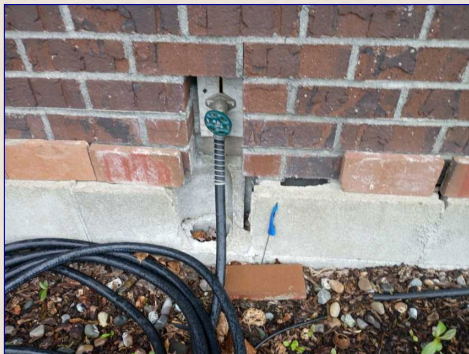
Hose bib operational.

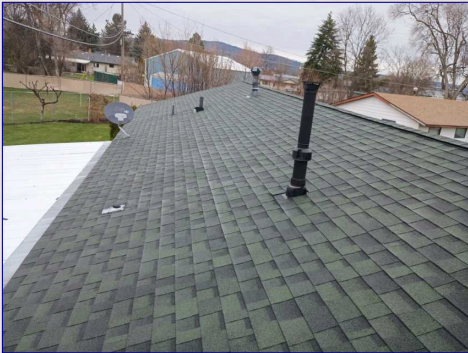
• This inspection is made on the basis of what is visible and accessible on the day of inspection and is not a warranty of the roof system or how long it will be watertight in the future. Many leaks occur only under conditions of prolonged rain, and these conditions may not be present at the time of inspection. Clients are encouraged to ask the current owner about the presence of any roof leaks. We do not inspect for the insurability of the home and roof and whether it meets with your insurance companies underwriting approval. Recommend your insurance company pre-approve the roof and related covered items before closing.

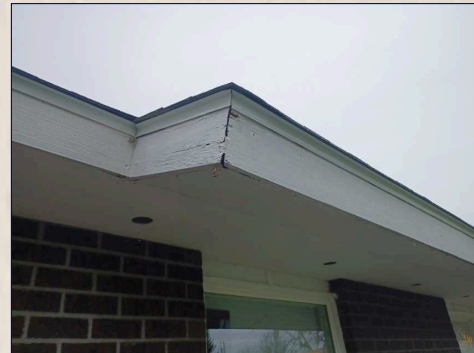
Roof Flashing. Soffit / Fascia needs maintenance

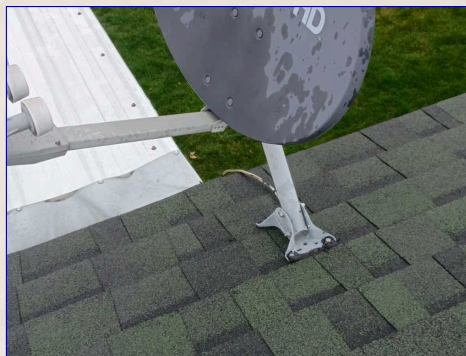
- There was a satellite dish installed on the roof, This is a potential penetration point for moisture. Recommend monitoring and contact a licensed roofer as needed.

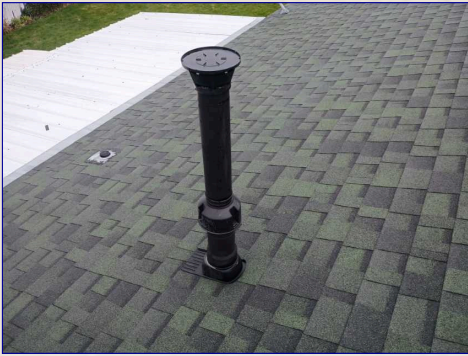
On Demand Water Heater Vent

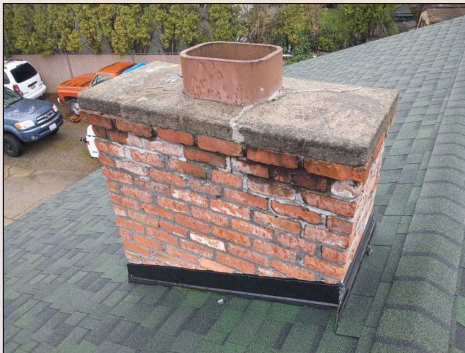
- The chimney flue is not visible and could not be evaluated. Recommend a licensed chimney sweep clean and evaluate before use.
- There is brick face popping off at the chimney. Recommend a qualified contractor evaluate and repair.
- **The concrete chimney cap is cracked in several locations. Recommend a licensed professional evaluate and seal the cracks/replace the chimney cap as needed.**
- Missing/loose mortar in the brick joints at the chimney, recommend a licensed contractor repair.
- **A rain cap/spark arrestor is missing on the chimney. Recommend a licensed contractor install a rain cap/spark arrestor on the chimney.**

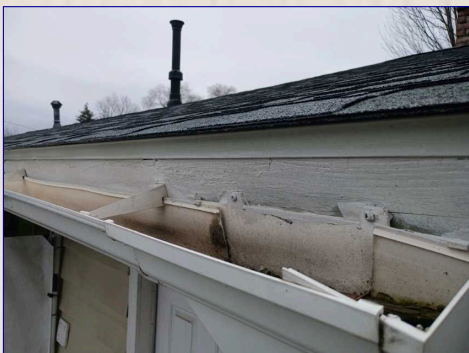
The gutters are dirty. Recommend cleaning the gutters

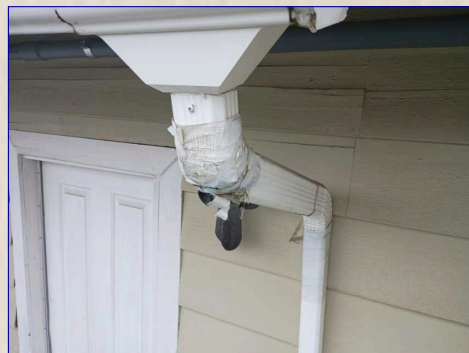
The gutter downspouts had some visible damage.

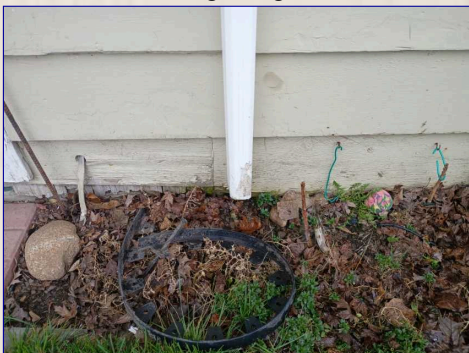
The gutter downspouts don't direct water far enough away from the house.

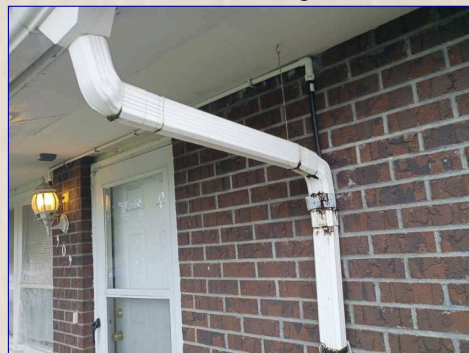
The gutter downspouts had some visible damage.

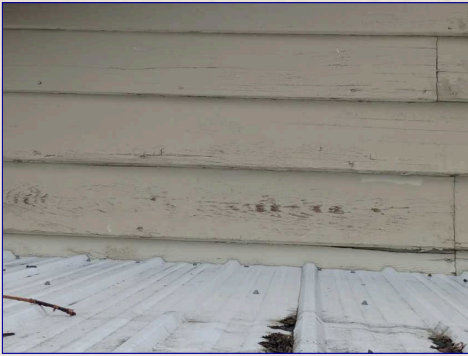
The siding needs routine repair and painting maintenance.

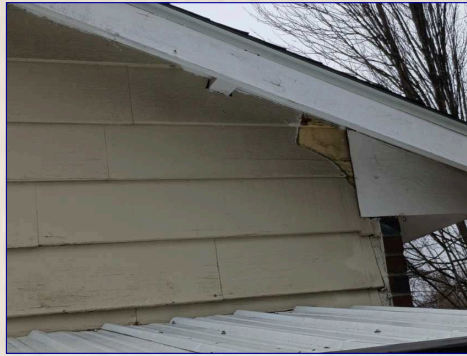
The siding needs routine repair and painting maintenance.

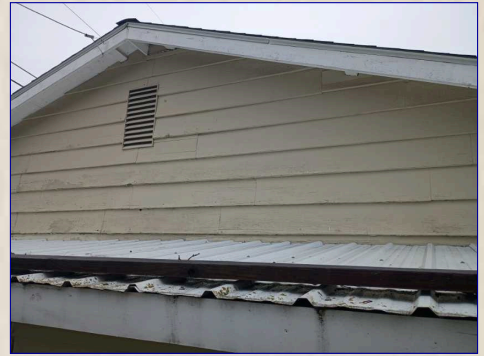
The siding needs routine repair and painting maintenance.

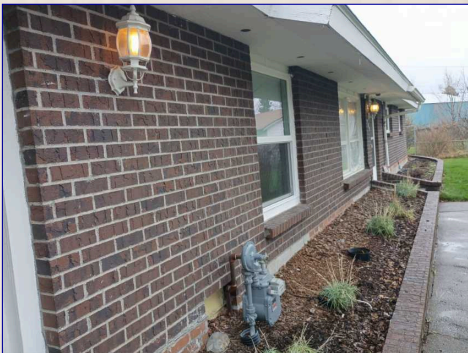
Brick veneer siding view

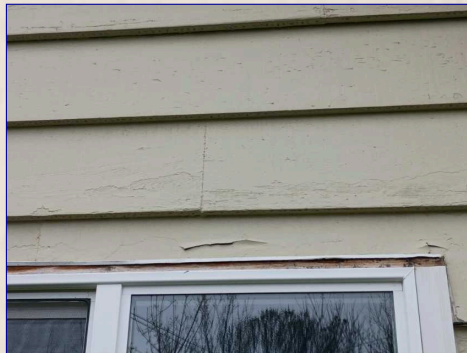
The siding needs routine repair and painting maintenance.

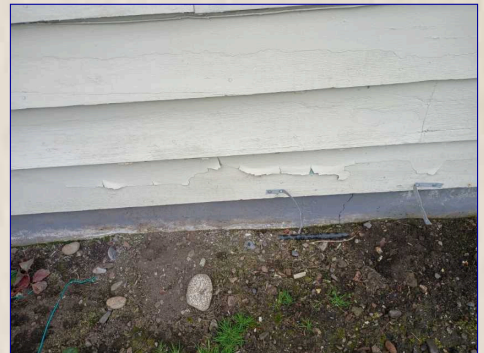
The siding needs routine repair and painting maintenance.

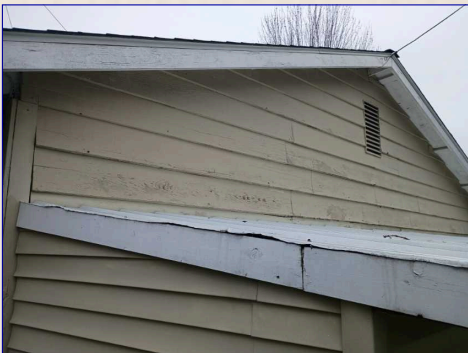
The siding needs routine repair and painting maintenance.

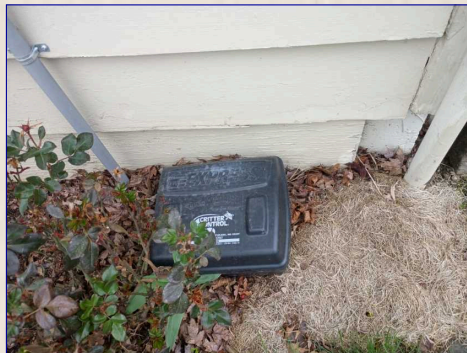
The siding is in contact with the soil.

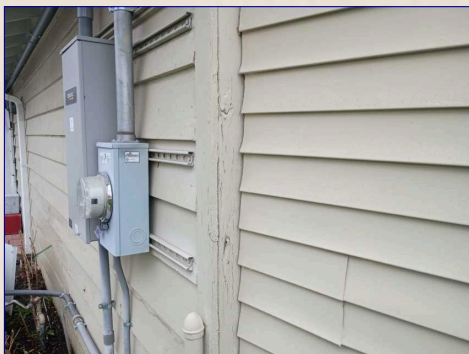
Some of the trim was damaged.

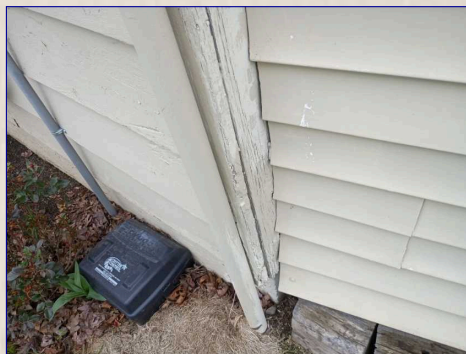
Some of the trim was damaged.

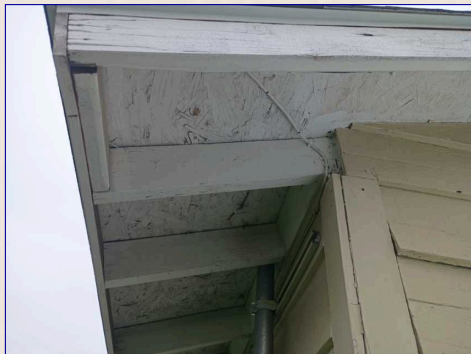
- One or more soffit areas had previous moisture damage. Recommend monitoring and repair as needed.
- The soffit needed routine painting maintenance. Recommend a professional painter repair/paint as needed.
- The soffit has areas of sagging. Recommend a licensed contractor repair/re-secure.

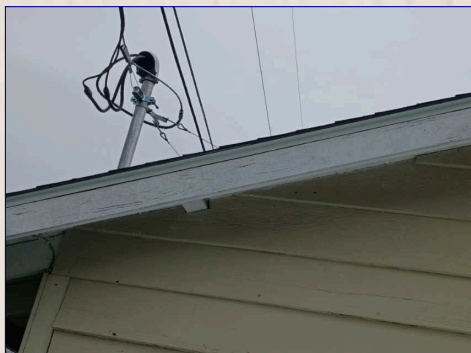
The fascia needs routine painting maintenance.

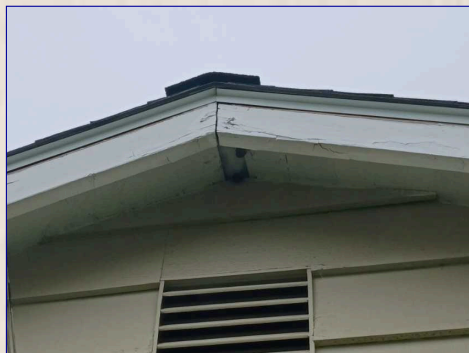
The fascia is loose, recommending a licensed contractor re-secure.

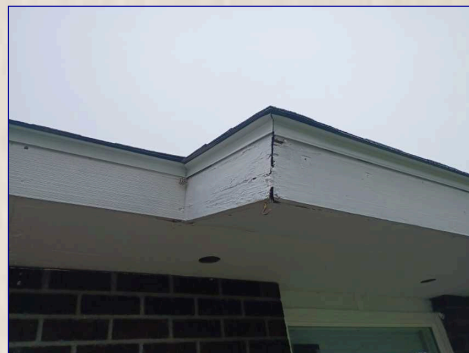
Fascia / Soffit needs maintenance

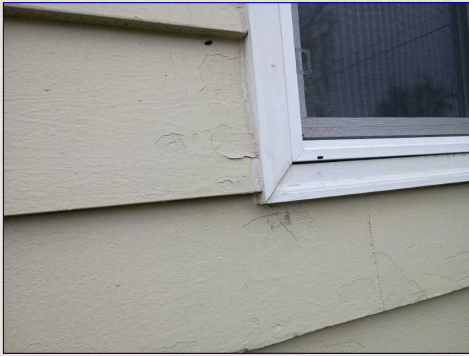
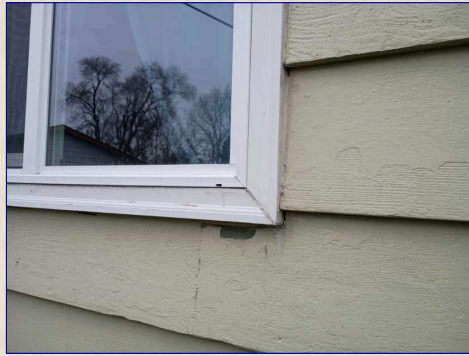
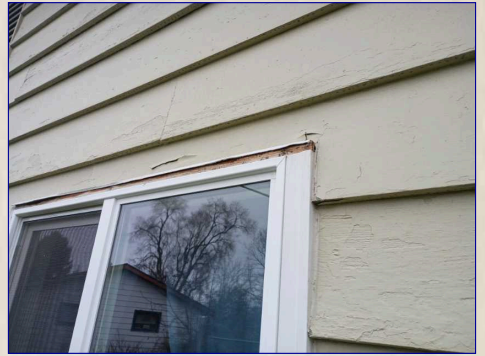
Recommend caulking around windows. Recommend caulking around windows. Recommend caulking around windows.

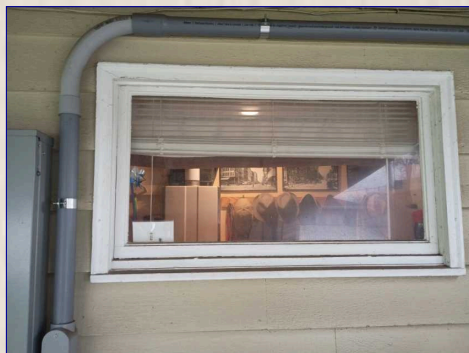
Exterior (continued)

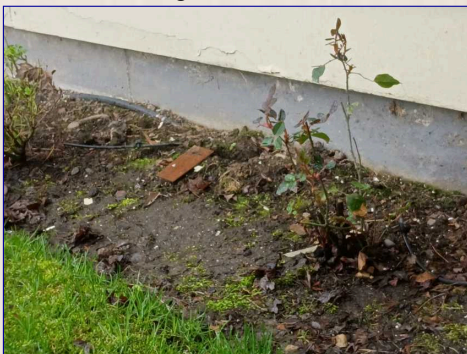
Foundation wall view.

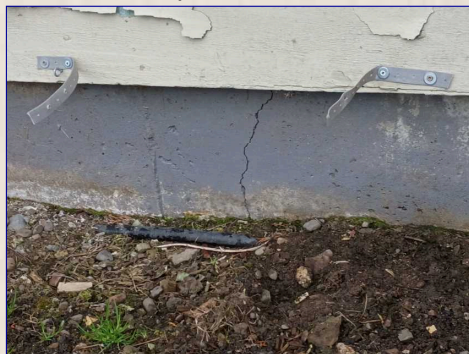
There are expected vertical cracks in the foundation.

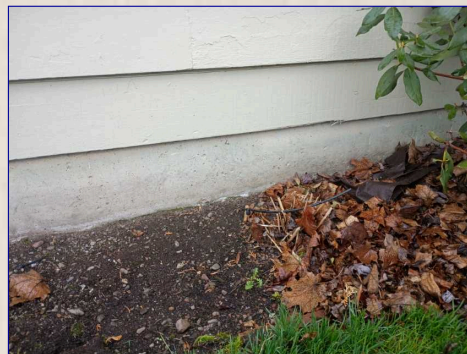
Foundation wall view.

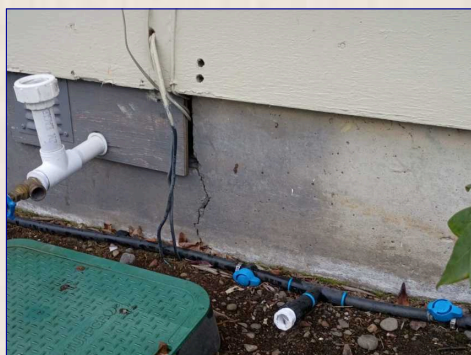
There are expected vertical cracks in the foundation.

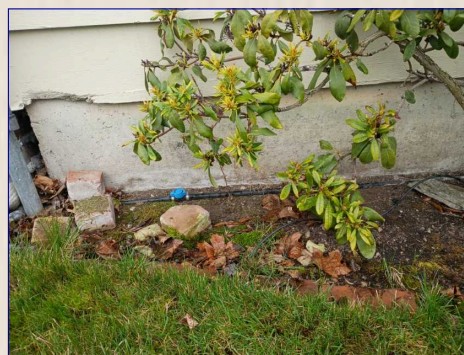
Foundation wall view.

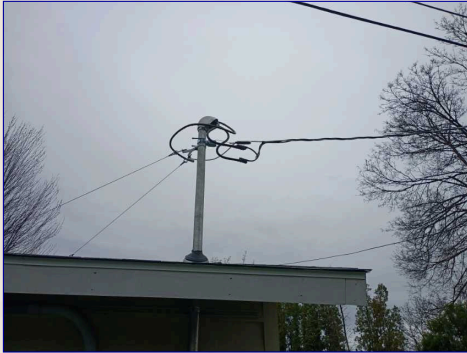
The electrical service entrance

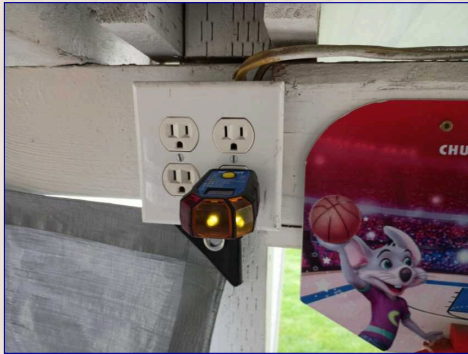
Exterior Receptacle Operating

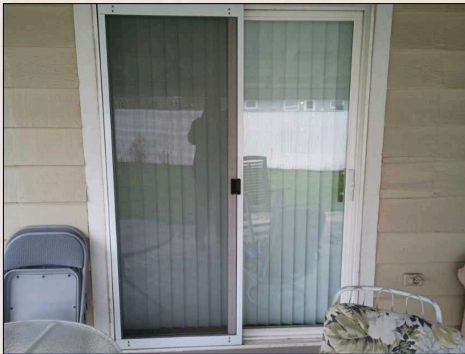
- Door one condition: Satisfactory
- Door two condition: Satisfactory
- Door three condition: Satisfactory

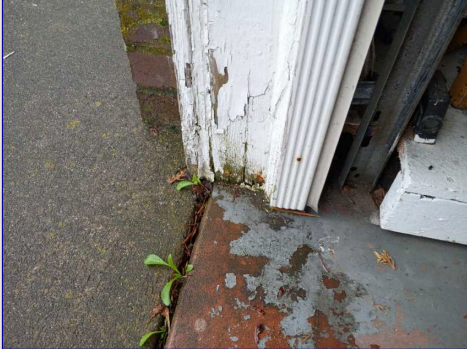
The garage exterior trim needed routine painting maintenance. Recommend a professional painter repair/paint the exterior trim.

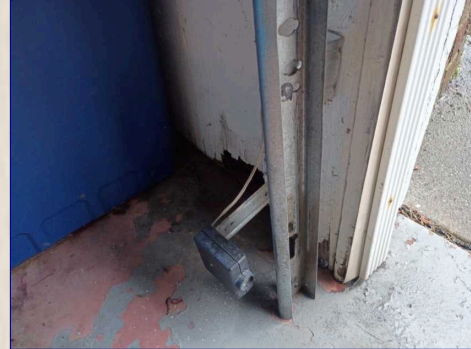
The garage exterior trim needed routine painting maintenance. Recommend a professional painter repair/paint the exterior trim.

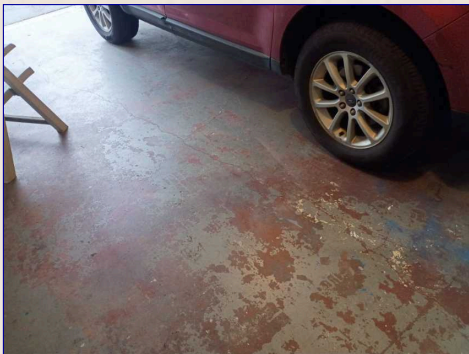
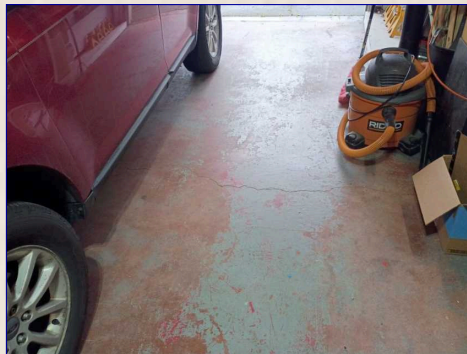
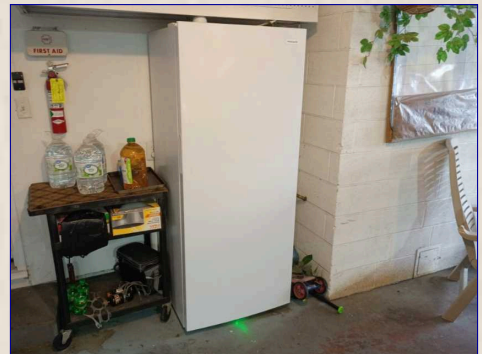
The garage floor has expected cracks. The garage floor has expected cracks. Ignition source should be 18" from floor

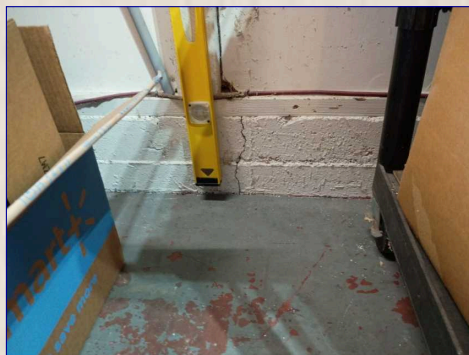
There are expected vertical cracks in the foundation.

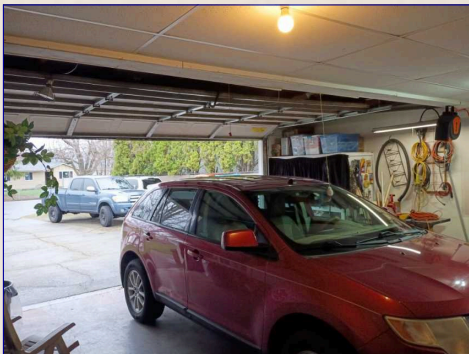
Garage overhead door view.

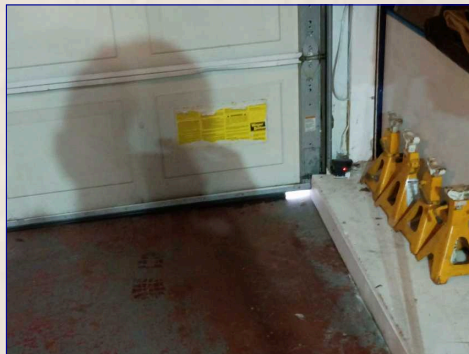
The garage door weatherstripping is missing or damaged.

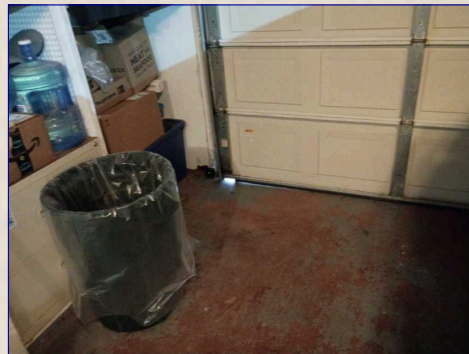
The garage door weatherstripping is missing or damaged.

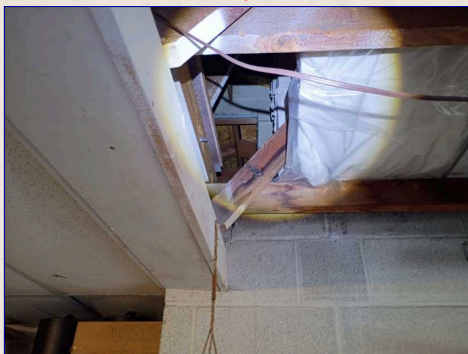
Access hole open in fire separation wall between Garage and House

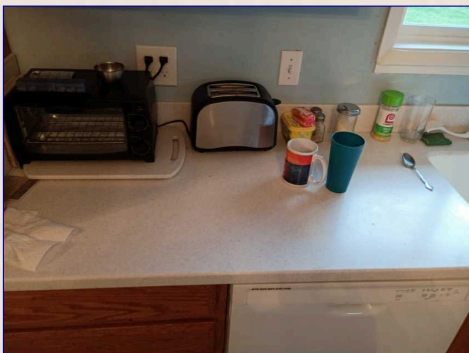
The caulk was missing dried or cracked.

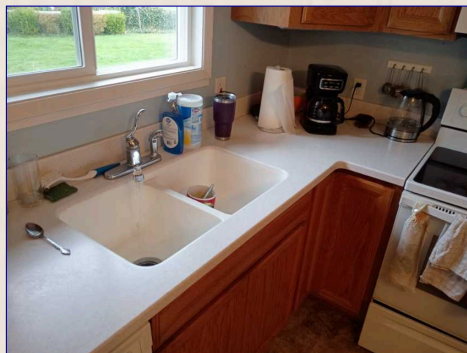
The kitchen countertop

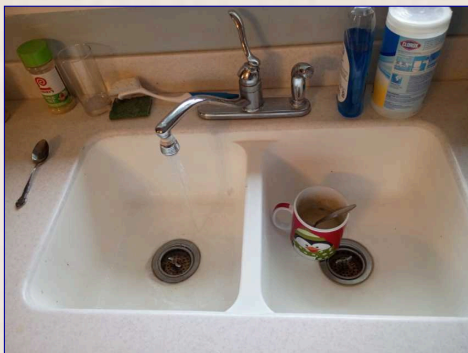
Kitchen faucet/sprayer operating

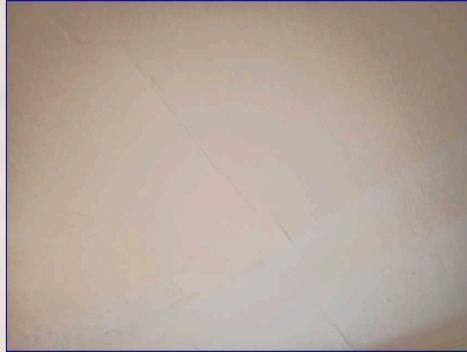
Cracking in Ceiling at Kitchen

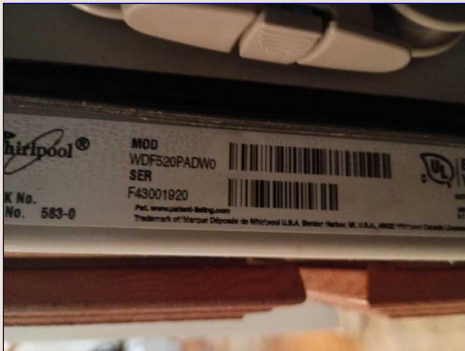
Dishwasher Data Tag. Model: WDF520PADW0 SN: F43001920

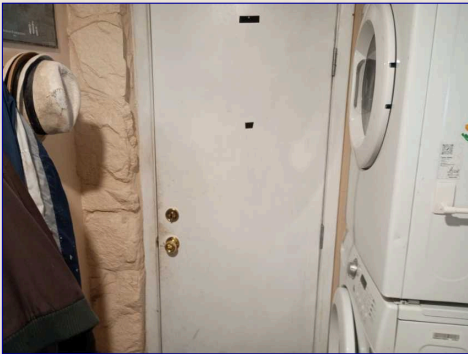
The Laundry Room View

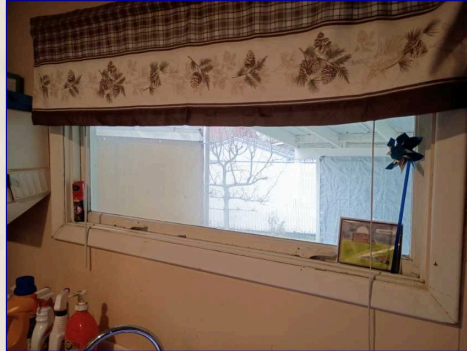
- Some window screens are torn, damaged, or missing. Repair/replace as needed.
- **The window not operating. Recommend a professional contractor repair.**

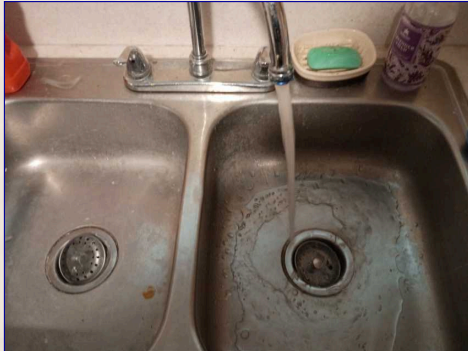
- Flex tubing is being used as part of the drain system in the kitchen. This is a nonprofessional installation of drain piping. Recommend a licensed plumber repair.

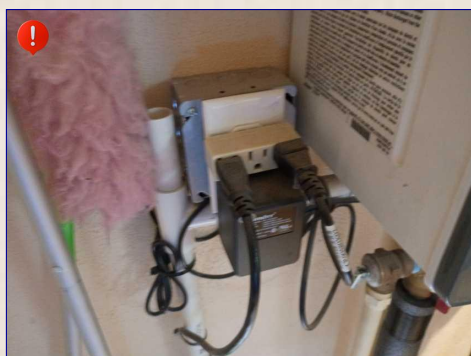
Multi Tap Electrical Receptacle

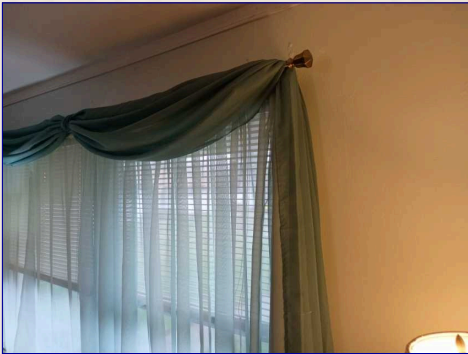
The ceiling/walls had cracking in various rooms. Recommend a licensed contractor repair as needed.

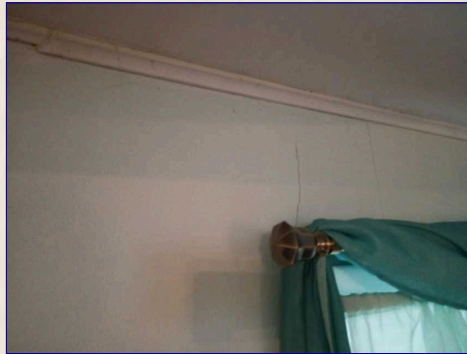
The ceiling/walls had cracking in various rooms. Recommend a licensed contractor repair as needed.

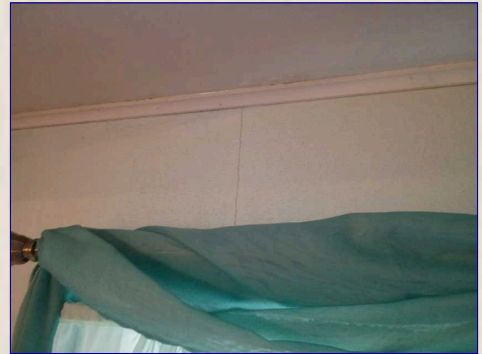
The ceiling/walls had cracking in various rooms. Recommend a licensed contractor repair as needed.

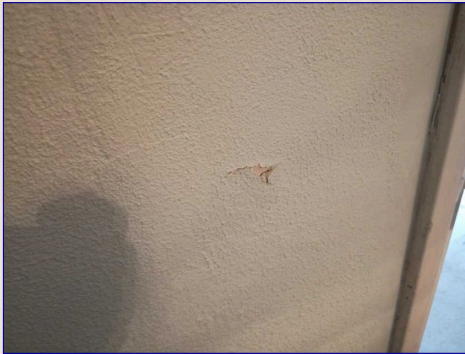
Wall Damage in Living room

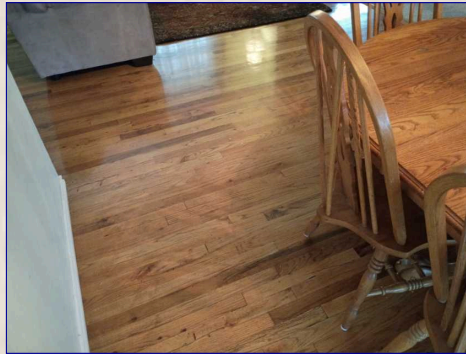
Living Room Flooring.

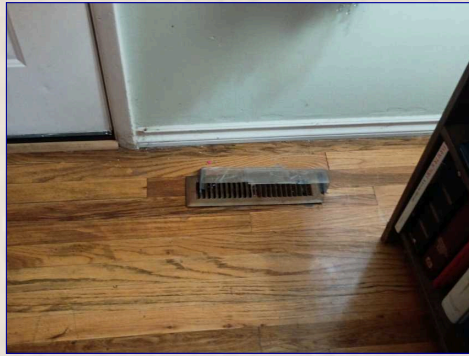
The heating vent has become damaged

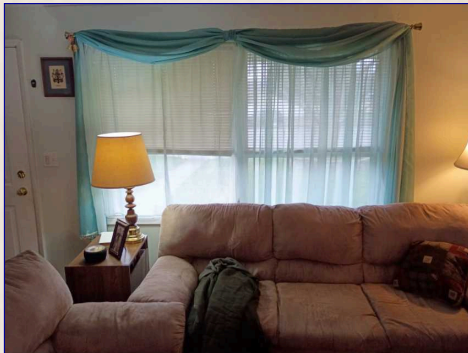
One or more windows had damaged or missing hardware. Recommend repairing. Consult a professional contractor as needed.

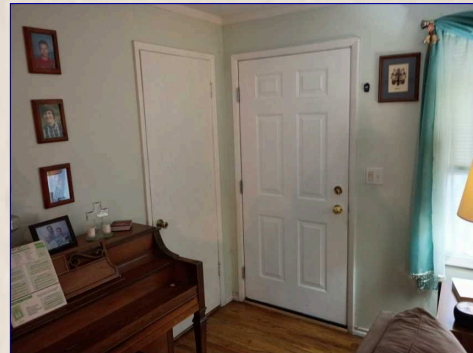
Door 1 Interior View

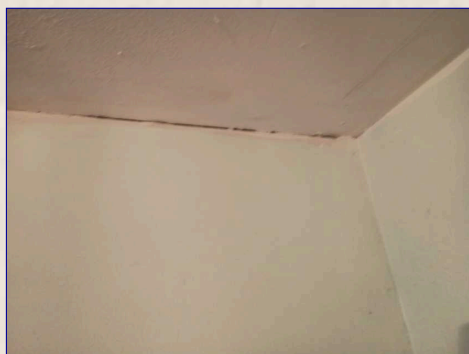
There is staining on the room ceiling.

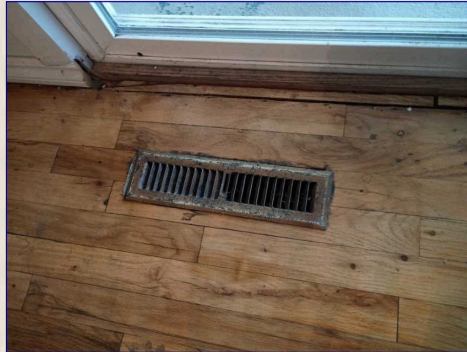
The heating vent has become damaged

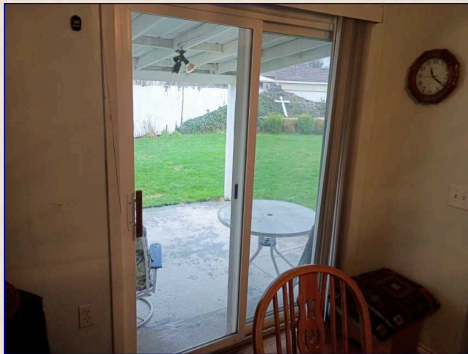
Door 2 at Dining Room

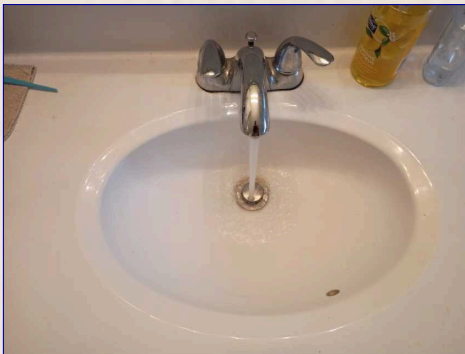
Sink faucet operating

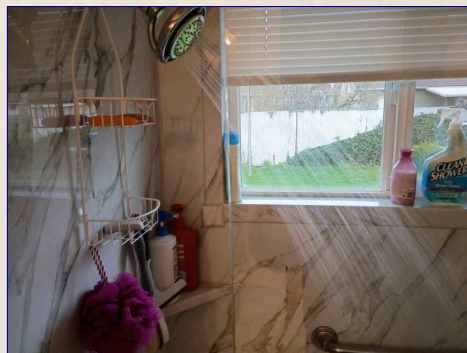
- Bathtubs: N/A
- Shower faucet leak: No
- Shower pipes leak: No
- Shower/Bathtub Area: Fiberglass
- Shower/Bathtub Area - Caulking needed: No
- Shower/Bathtub Area - Shower floor damaged: No

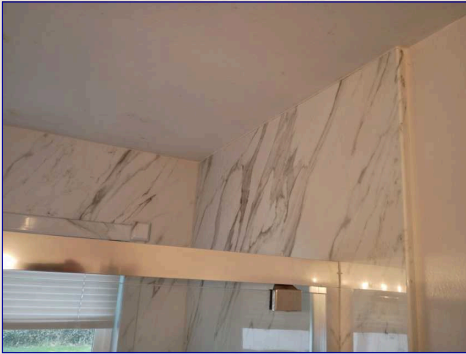
- Moisture Stains Present: No

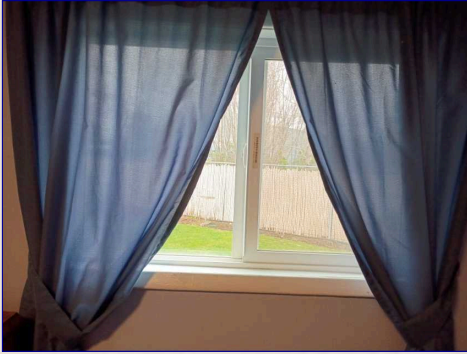
Bedroom 1 Window. Egress Restricted.

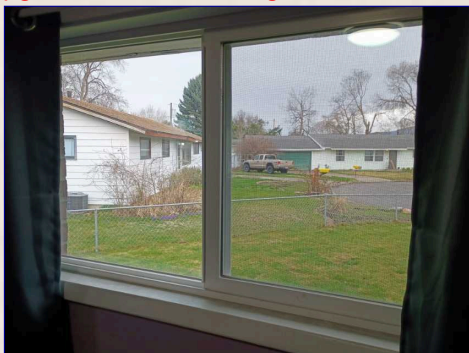
Bedroom 2 Window. Egress Restricted.

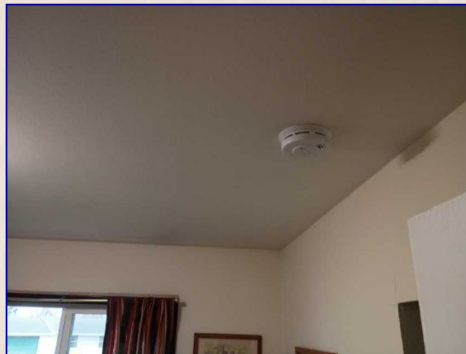
Bedroom 3 Smoke Detector

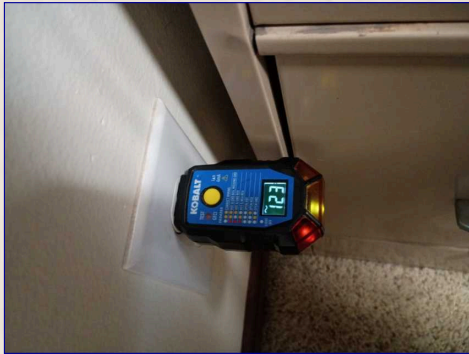
Electrical Receptacles in Bedroom 3 Wired incorrectly

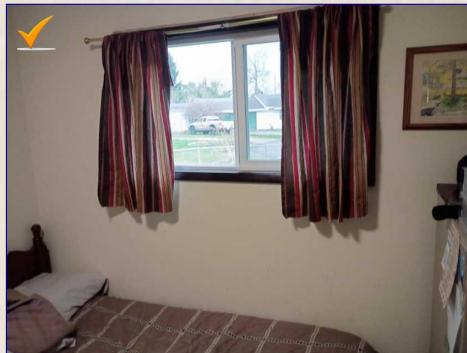
Bedroom 3 Window Egress Restricted.

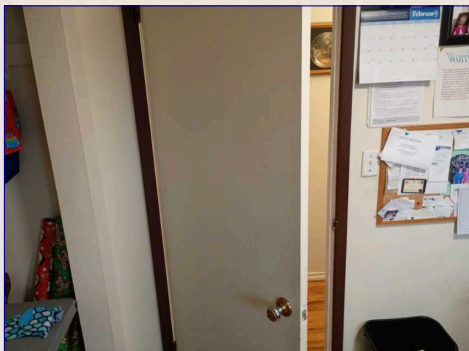
Bedroom 3 door does not latch properly

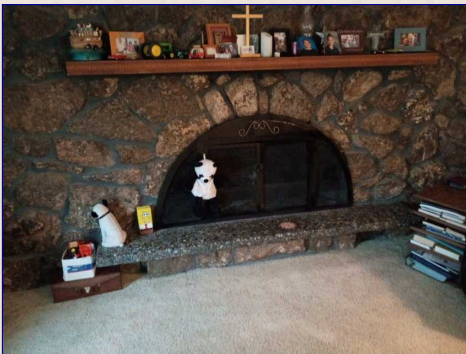
- The fireplace chimney damper is missing/damaged. Recommend a licensed chimney sweep evaluation and repair.

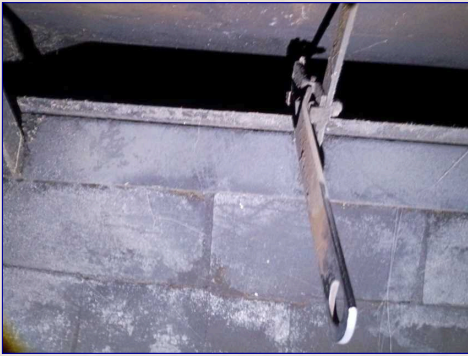
Fireplace damper is loose and does not stay closed securely.

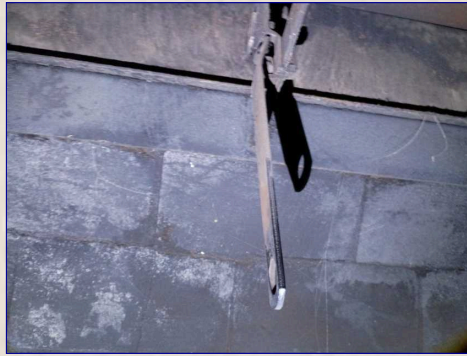
Fireplace damper is loose and does not stay closed securely.

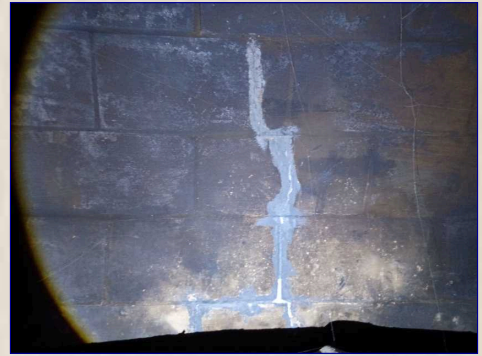
Firebrick Repair in Firebox

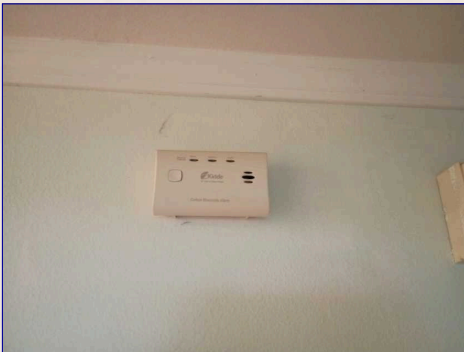
CO Detector in Main Hallway

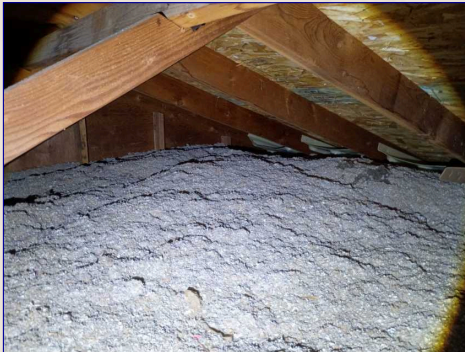
Attic Insulation View

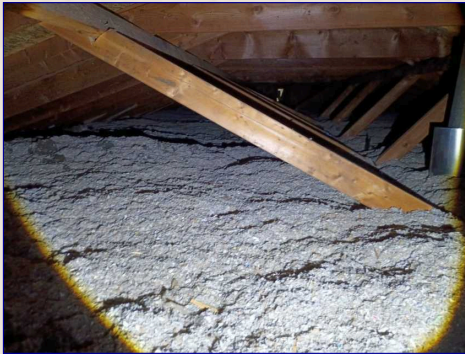
- There are cut rafters/trusses in the attic. Recommend a licensed structural engineer evaluate and repair or replace.

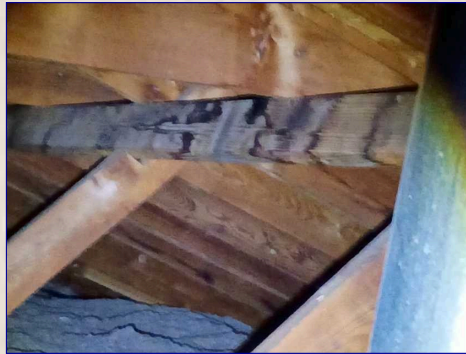
There are Moisture stained rafters/trusses in the attic. No Active moisture detected, Recommend Monitoring area above refrigerator in Kitchen

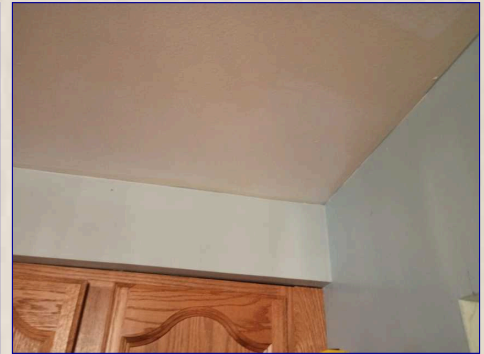
Location of potential water damage from Moisture stained beam

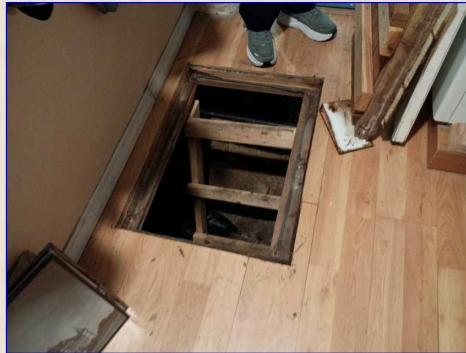
Crawlspace Access 2 in Laundry Room

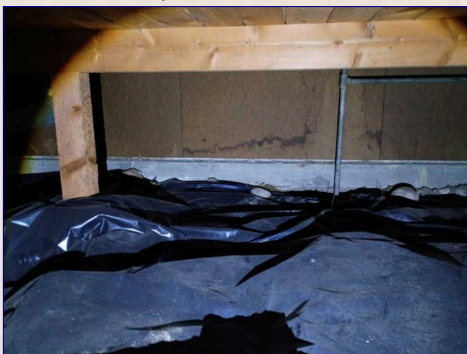
The crawlspace walls view

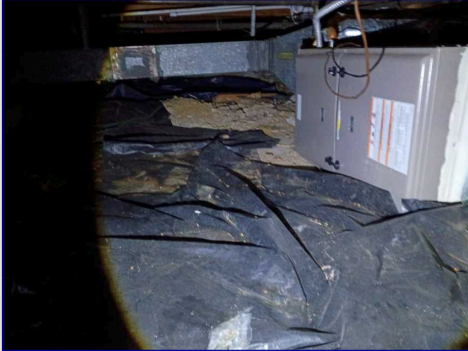
The crawl space floor

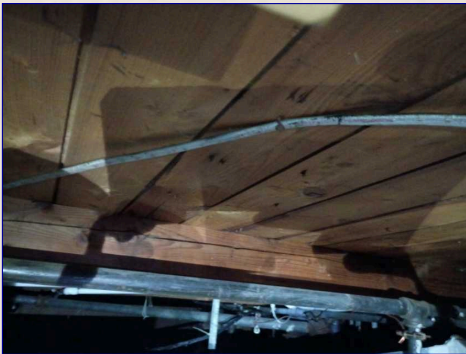
Cloth covered Romex Branch Wiring

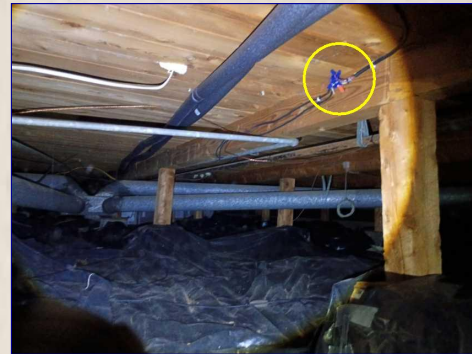
There are spliced electric wires outside of a junction box in the crawlspace. This is a safety concern. A licensed electrician should repair.

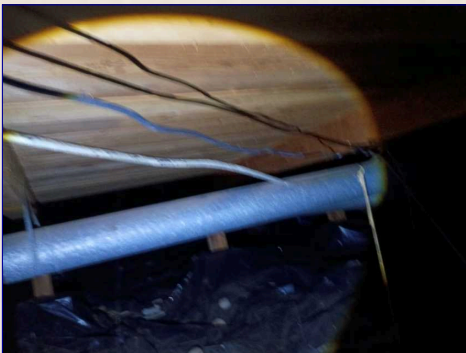
No visible insulation was noted in the crawlspace

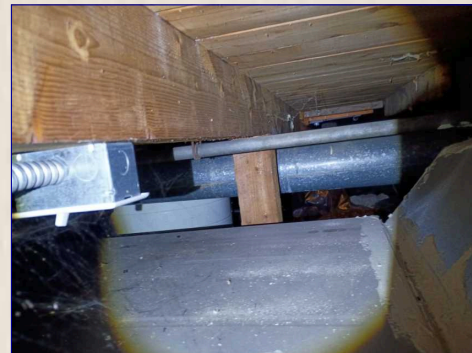
No visible insulation was noted in the crawlspace

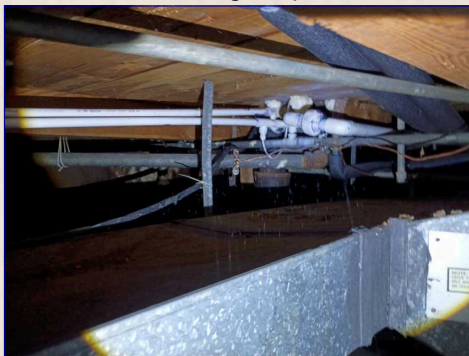
The visible drain/waste piping

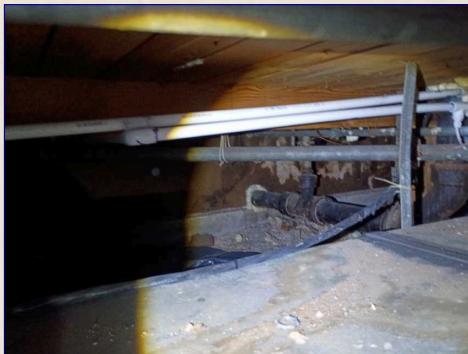
- Sewer lines from the main sewer line to the home are not visible and therefore are not part of the home inspection. This Lateral sewer line is the homeowner's responsibility. Therefore we recommend a sewer line scope/camera inspection by a qualified contractor.
- The drain/waste pipes in the home are rusted. Since the pipes are primarily underground, they are not part of the home inspection and are the homeowner's responsibility. It is recommended that a licensed plumber evaluate the entire cast iron system and make repairs as needed. Cast iron drain pipes have an expected life of 50-100 years and can be affected by various factors. The homeowner should consult with a licensed plumber for a regular piping inspection.

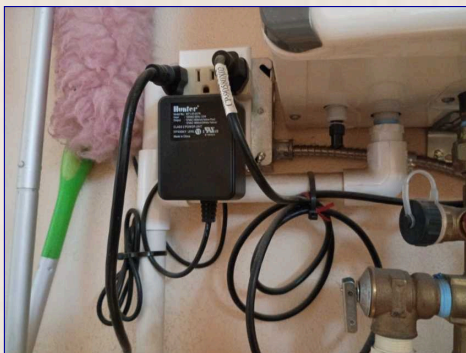
Multi Tap Electrical Receptacle at Water Heater

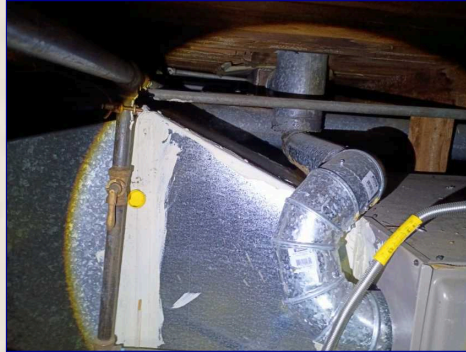
No carbon monoxide was detected. Recommend regular monitoring with proper carbon monoxide detectors. Consult a licensed HVAC technician as needed.

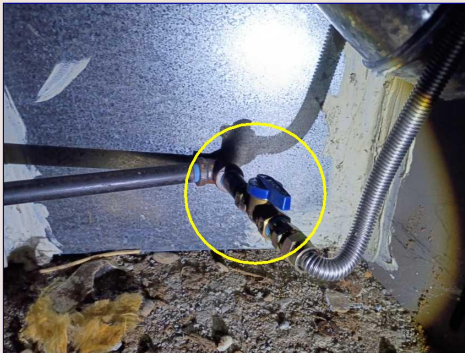
- **The furnace gas valve has an older style valve has been known to leak over time. We recommend a licensed contractor upgrade the gas valve for added safety and convenience.**

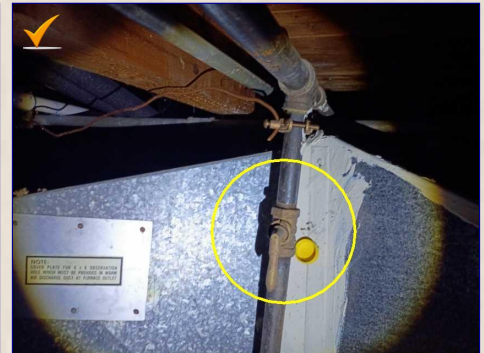
The OLD gas shutoff In line. - Recommend removing as Old Brass valves are known to leak at handle.
